**SUBJECT: LOWER CURTAIN ASSEMBLY – ALL CIM
Part # 9051823-01**

**Number: 2020-01.1
Product: CIM Cubers
Date Issued: JAN 2020
Date Updated: May 2021
From: Technical Services**

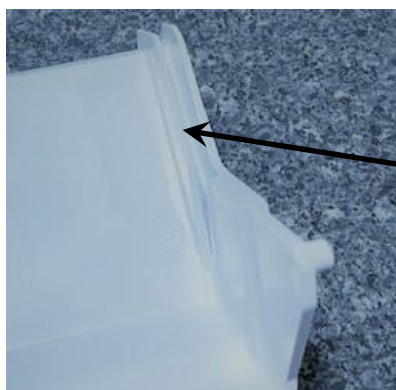
Updated Lower Curtain Assembly to aid in water redirection on the bottom of the Evaporator. On any CIM Cuber with broken tabs on the Water Return at the bottom of the Evaporator, installing the new Curtain will assist in water being directed back into the Water Sump.

← Extended rib (inside the outer rib) on Curtain directs water into the Sump.

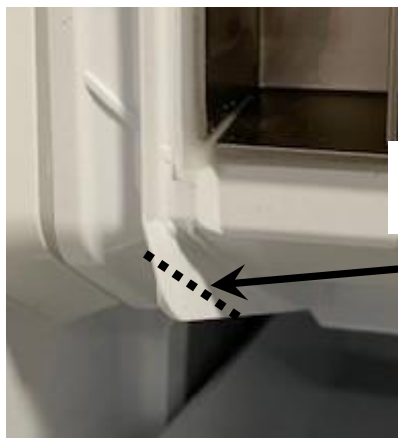
**NOTE: DON'T TRIM TABS FLUSH
TO BOTTOM OF EVAPORATOR**

Trim remaining tabs about 3/16" to 1/4" from bottom of Evaporator(s)
