**SUBJECT: LOWER CURTAIN ASSEMBLY – ALL CIM
Part # 9051823-01**

**Number: 2020-01
Product: CIM Cubers
Date Issued: JAN 2020
From: Technical Services**

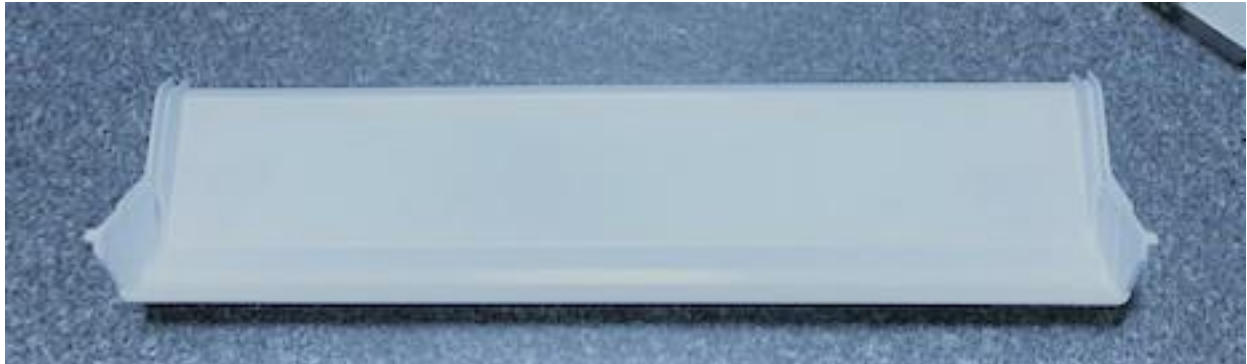
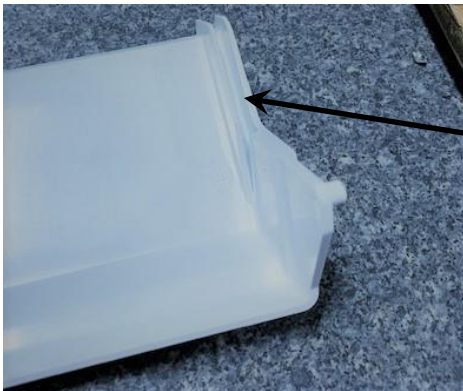
Continuing our efforts for Product improvement, we have updated the Lower Curtain Assembly to aid in water redirection on the bottom of the Evaporator. On any CIM Cuber with broken tabs on the Water Return at the bottom of the Evaporator, installing the new Curtain will assist in water being directed back into the Water Sump.

Extended tab on Curtain directs water into the Sump.
